Maine Forestry Best Management Practices Use and Effectiveness 2005-2009

Department of Conservation
Maine Forest Service
22 State House Station
Augusta, Maine 04333
Forest Policy and Management Division

December 2010

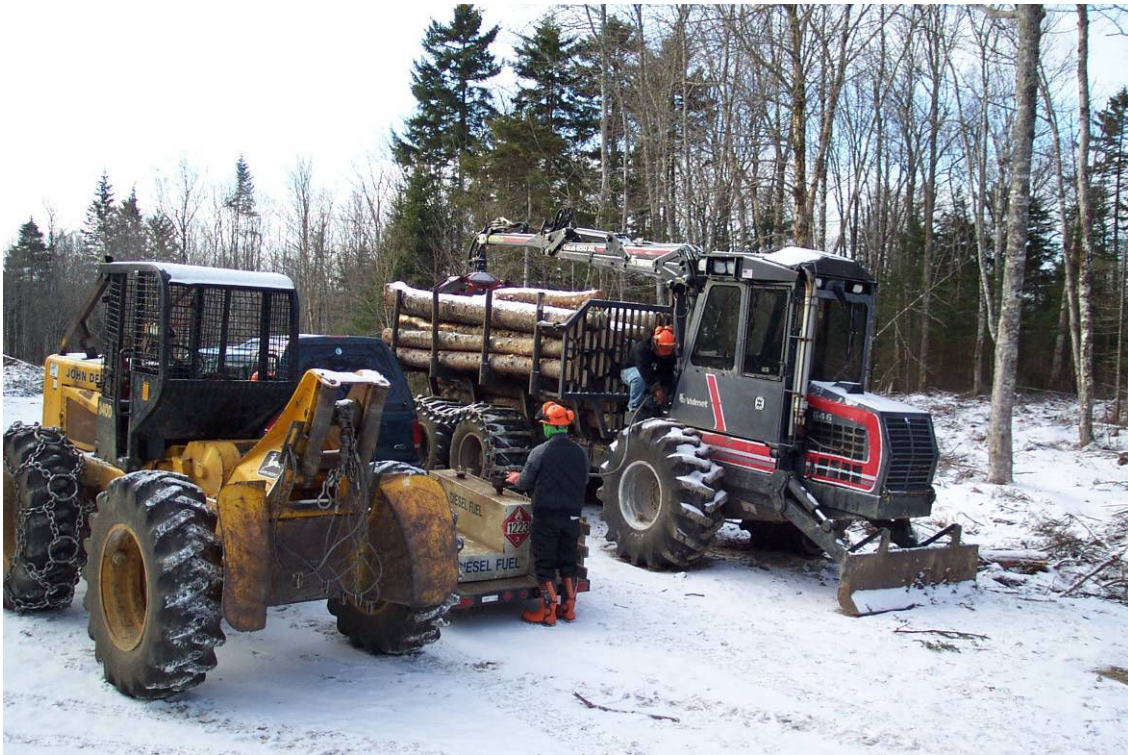
When used properly carried wood systems (e.g. the forwarder seen on the right) can result in less soil disturbance vs. dragged wood systems (e.g. the cable skidder seen on the left). Regardless of the type of system used, operator skill and training are critical to good results.

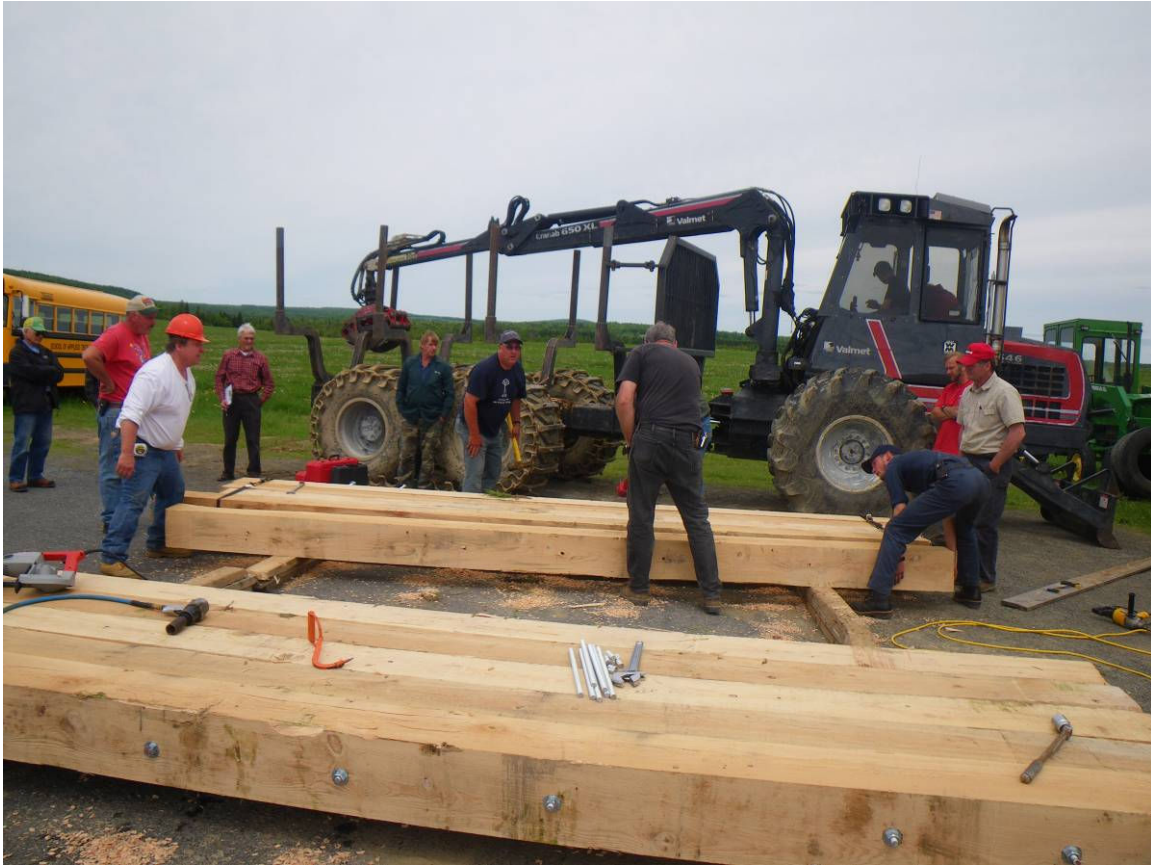
The Maine Forest Service and the Maine Sustainable Forestry Initiative sponsored skidder bridge mat workshops are designed to reduce stream crossing sedimentation by teaching loggers how to construct and install temporary skidder bridges. This program also provides direct assistance by providing skidder bridges that are available as free loaners at host mills.

In previous years reports, sedimentation originating from the crossing structure has been identified as a problem area. In response to this issue MFS and its partners including Maine SFI, Certified Logging Professional program, Qualified Logging Professional program, and the Northeast Master Logger Certification Program have targeted training to address the issue. Over 600 loggers, foresters and landowners have attended BMP related training sessions over the past two years. The MFS has also expanded its temporary skidder bridge loaner program so that four sets of steel skidder bridges and about 20 sets of wooden skidder bridges are available for loan to loggers across the state.

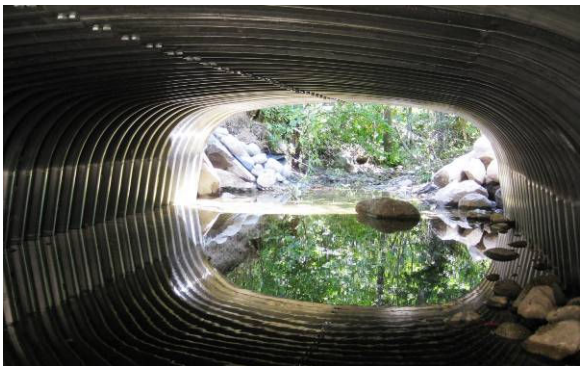
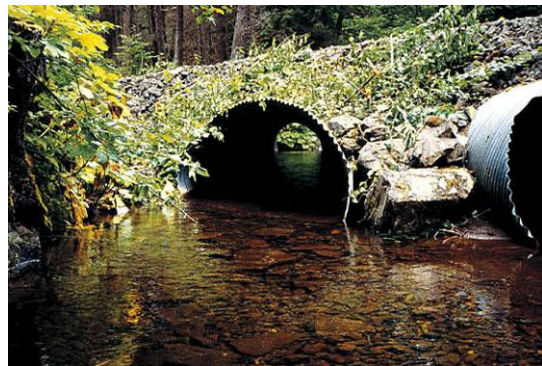
Stream crossing structures such as bridges and open bottom culverts that are open to the natural stream bottom are least likely to impede the passage of fish and other aquatic organisms. Sizing and embedding round culverts so material can collect in the bottom can minimize impacts to fish passage.

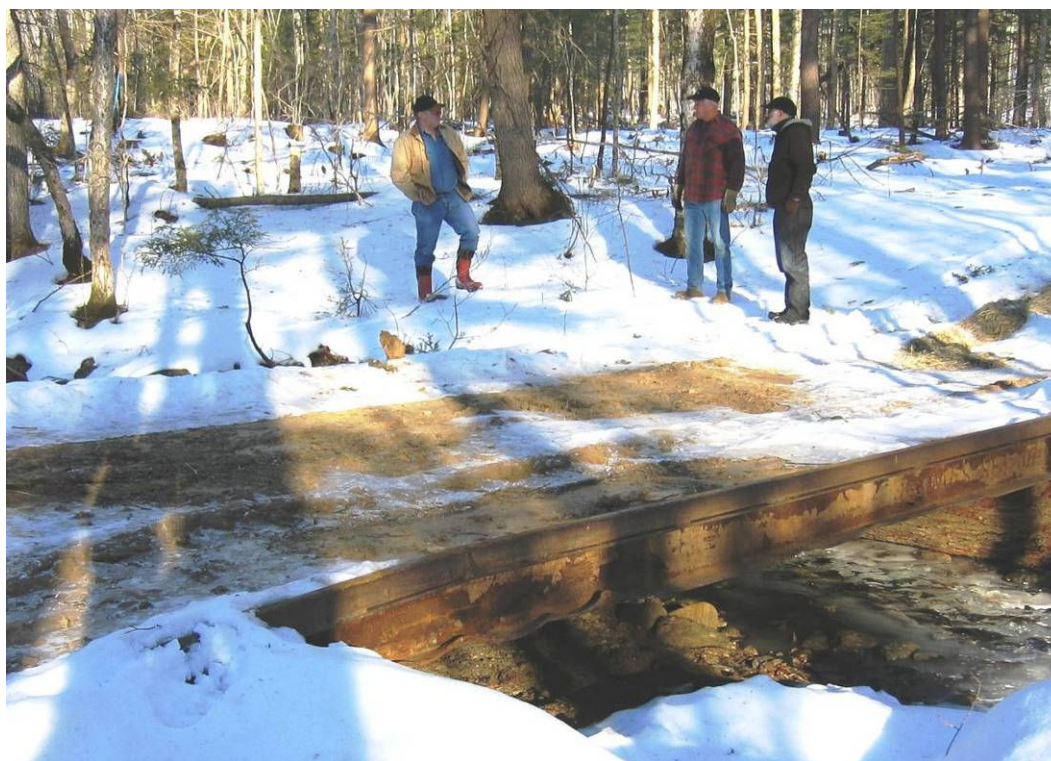
Temporary stream crossings do not require long term maintenance and are often less likely to impede fish passage. Options, such as the portable steel bridges pictured here, exist for temporary crossings on haul roads as well as skid trails.

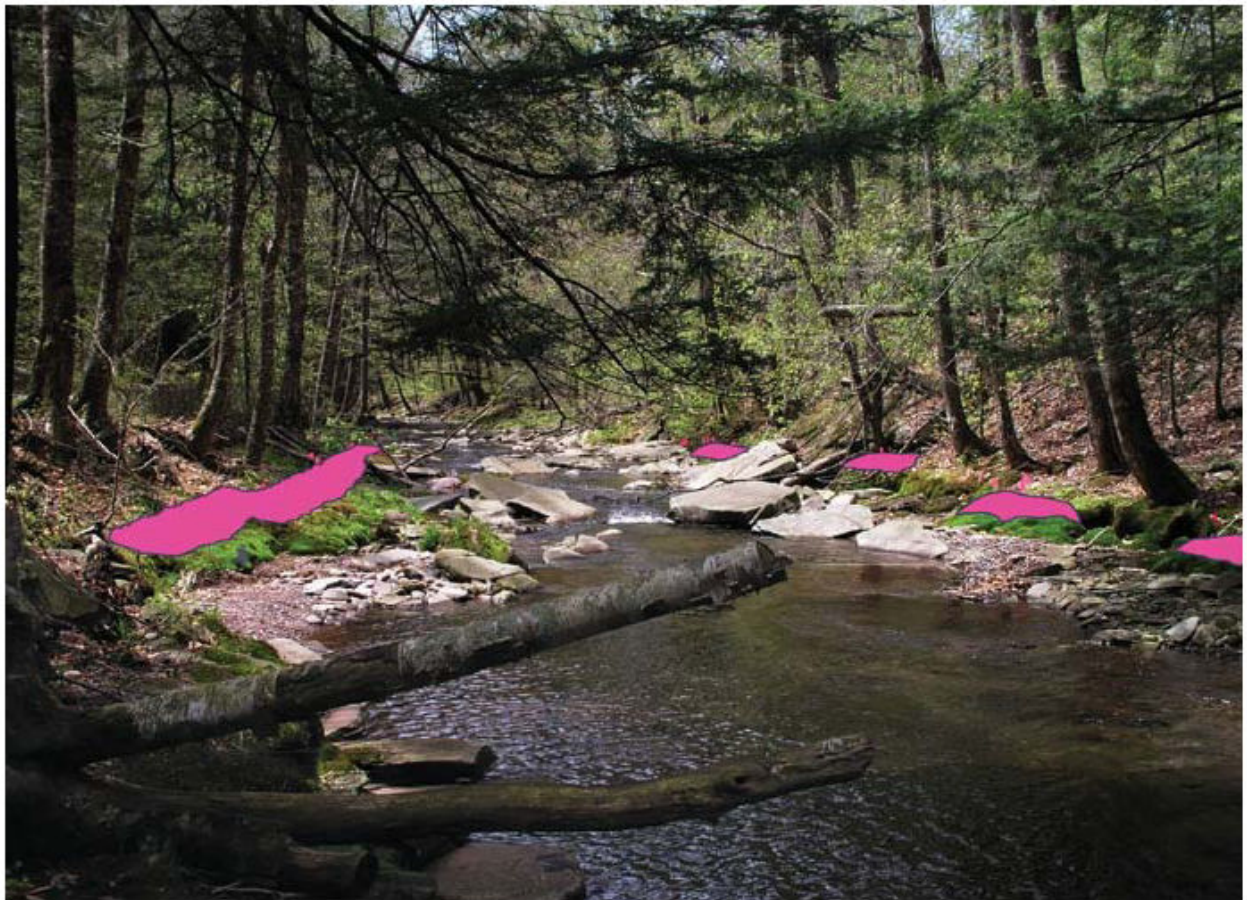
Bankfull indicators visible at low flow. The bankfull elevation is indicated by the first depositional flat above the channel. On very confined channels, the bankfull elevation may only be evident as the discontinuous flat depositional areas shaded on the photo.

Bankfull elevation is the maximum elevation of the annual spring flood 2 years out of three. As such, it is also point of demarcation between the stream channel and the floodplain. The bankfull elevation is at the elevation of the lowest depositional flat immediately above the channel and is often identified by the deposition of fine sediments indicated by the first depositional flat above the channel.

Bankfull width is the channel width from the bankfull elevation on the one side of the channel to the bankfull elevation on the other side of the channel.
